NBSIR 86-3387

**INVESTIGATION OF THE CORROSION OF
ALUMINUM STANDING-SEAM
ROOFING AT AN ARMY FACILITY**

Robert G. Mathey

June 1986

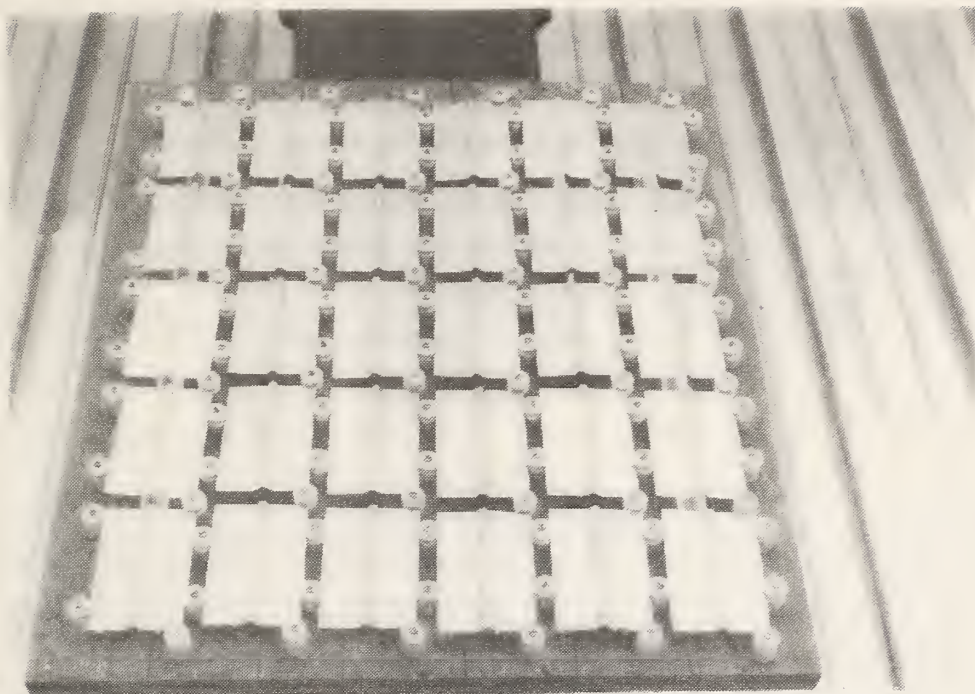
Figure 1. Aluminum roofing samples mounted on exposure test rack

Thirty samples were mounted on a rack and exposed at the same angle as the roofing. Figures 1 and 2 show the exposure rack mounted on the firewall of one of the warehouses at DCSC. The exposure rack faced west.

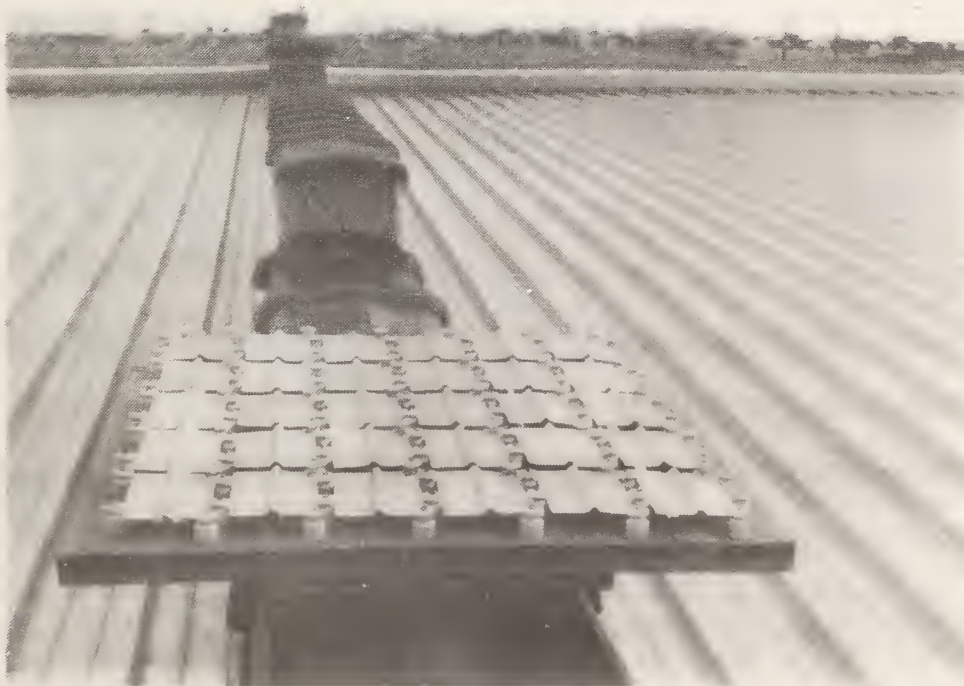
Figure 2. Exposure test rack attached to fire wall between sections of roofing

without introducing stress in them. The samples were not in contact with any other material. Round slots in the insulators where the samples were supported (figure 2) allowed some movement of the samples and still maintained their adequate attachment. The insulators were held in place by screws attached to the wood rack. The distance between the samples and the wood rack was about 7/8 in. (22 mm).
